1. AGENCY USE ONLY (Leave blank)	2. REPORT DATE 1996	3. REPORT TYPE AND DATES COVERED Final Report		
4. TITLE AND SUBTITLE The Old Hospital Complex (5EP1778) Fort Carson, Colorado		5. FUNDING NUMBERS

13. ABSTRACT (Maximum 200 words) <p>The Old Hospital Complex (5EP1778) at Fort Carson, Colorado, consists of 59 buildings. The Complex was built during World War II and is significant due to its association with the history of the United States. The complex is semi-permanent construction, constructed from the Department of the Army's Series 800 plans. This report documents the complex in accordance with Section 1(g) of the Memorandum of Agreement enacted among the Department of the Army, Headquarters Fort Carson, the Colorado State Historic Preservation Office, and the Advisory Council on Historic Preservation.</p> <p style="text-align: center;">DTIC QUALITY INSPECTED 2</p>

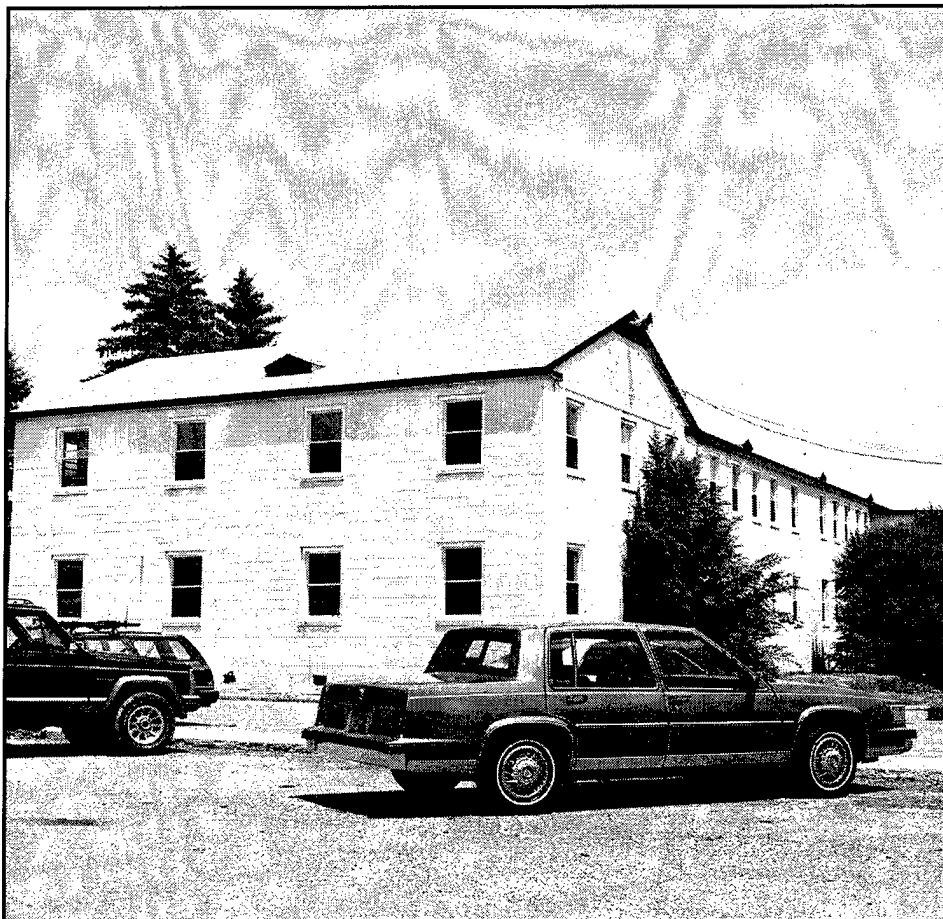
Figure V.9 5EP1778. Building S6225, Administration Building, 800 Series, Type HAB-1. Three-quarter view of south and west facades. Roll 11A, Exposure 9.

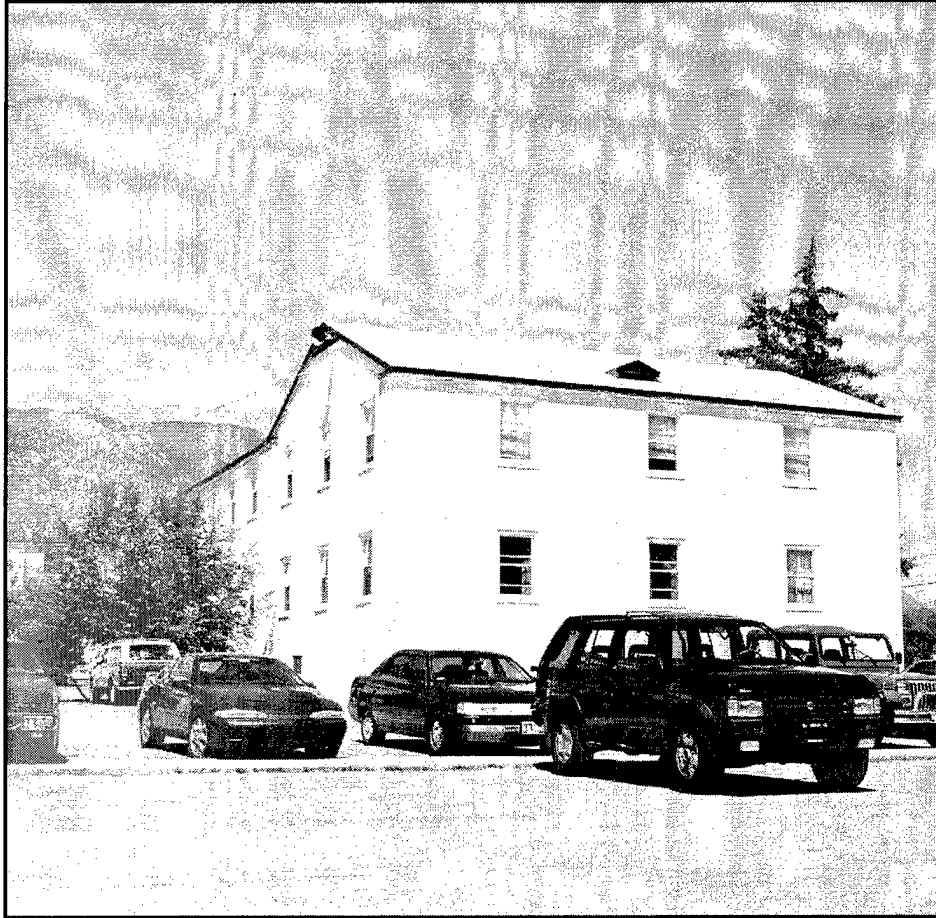
Figure V.10 5EP1778. Building S6225, Administration Building, 800 Series, Type HAB-1. Three-quarter view of south and east facades. Roll 17A, Exposure 5.

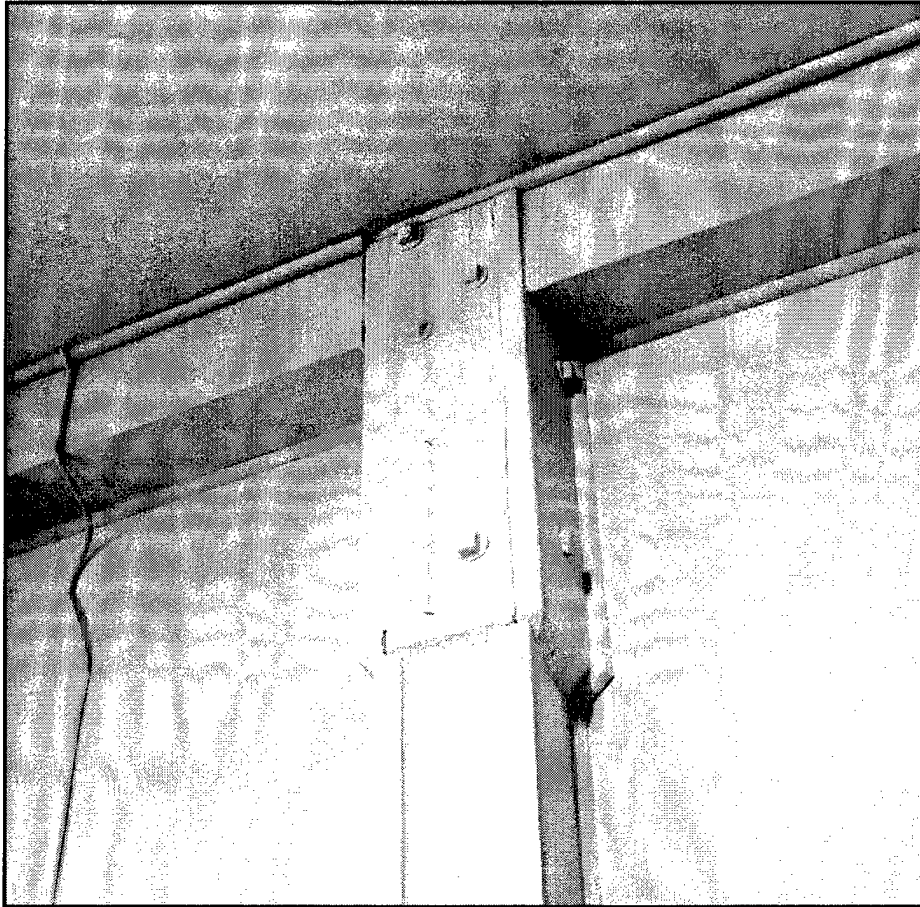
Figure V.12 5EP1778. Building S6225, Administration Building, 800 Series, Type HAB-1. Detail of wood column and joist in the second level of the west wing. Roll 4A, Exposure 12.

The structural system of S6225 consists of load-bearing cinder block exterior walls, and piers. The end stairwells are fully enclosed by cinder block walls. The east and west (gable) walls of the original construction remain, effectively dividing the length of the building into three structural volumes. The floor system is wood-joist construction. Joists bear on interior, built-up longitudinal beams. The second-floor beams transfer their load to the foundation piers via solid wood pillars. Floor joists are covered by diagonally laid, tongue-in-groove subflooring, and finish flooring. The roof is supported by wood-trussed rafters that bear on the perimeter walls.

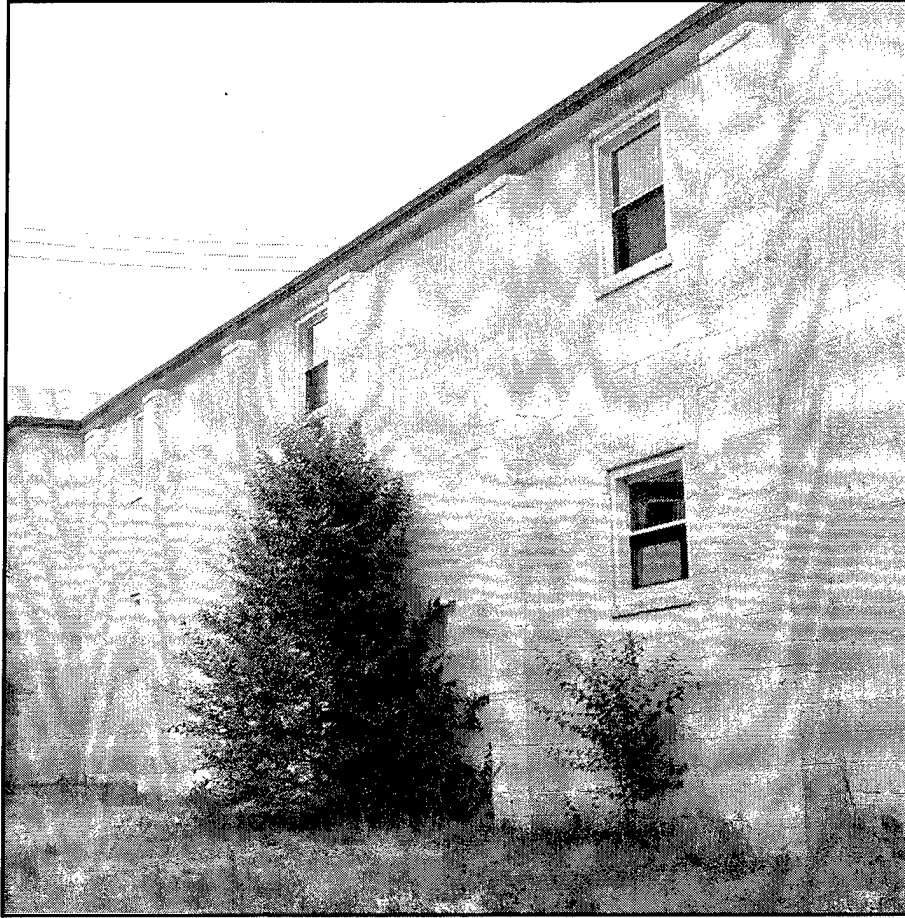
Figure V.13 5EP1778. West face of corridor connecting Buildings S6225 and S6226. View to the northeast. Roll 5A, Exposure 9.

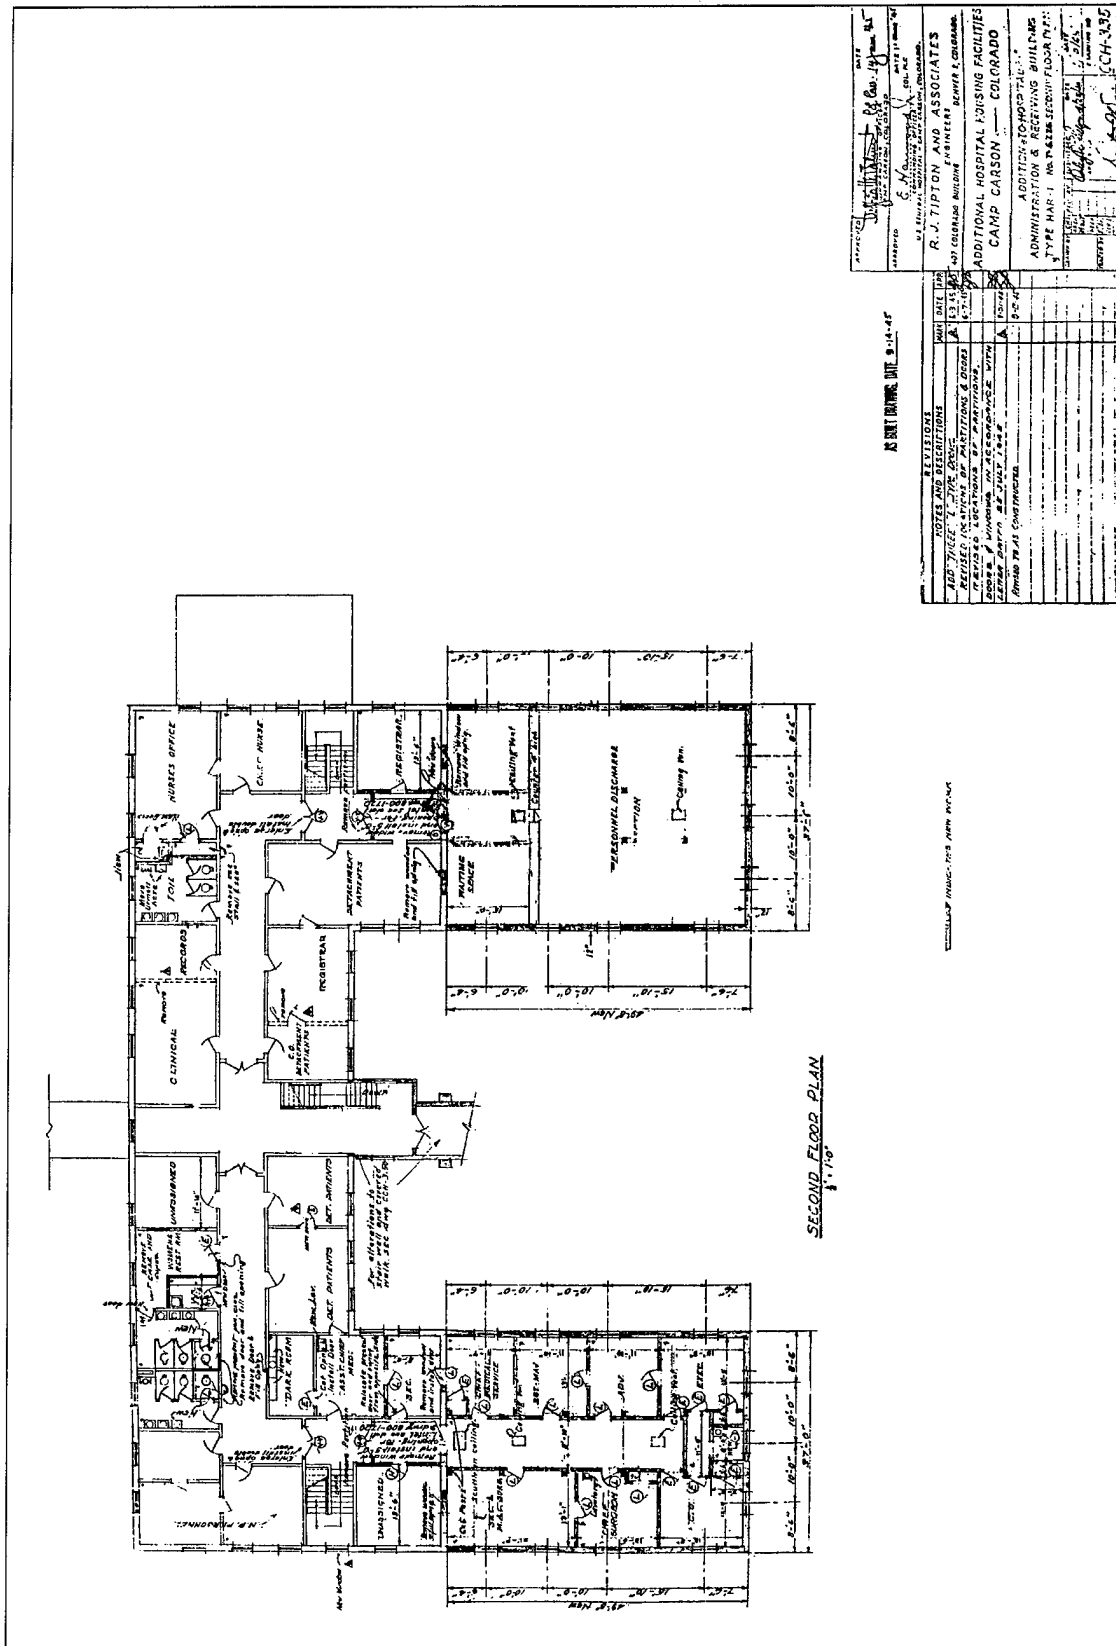
Figure V.20 5EPI778. Second-floor plan for Building S6226, Administration and Receiving, CCH Series, Sheet 3.35.

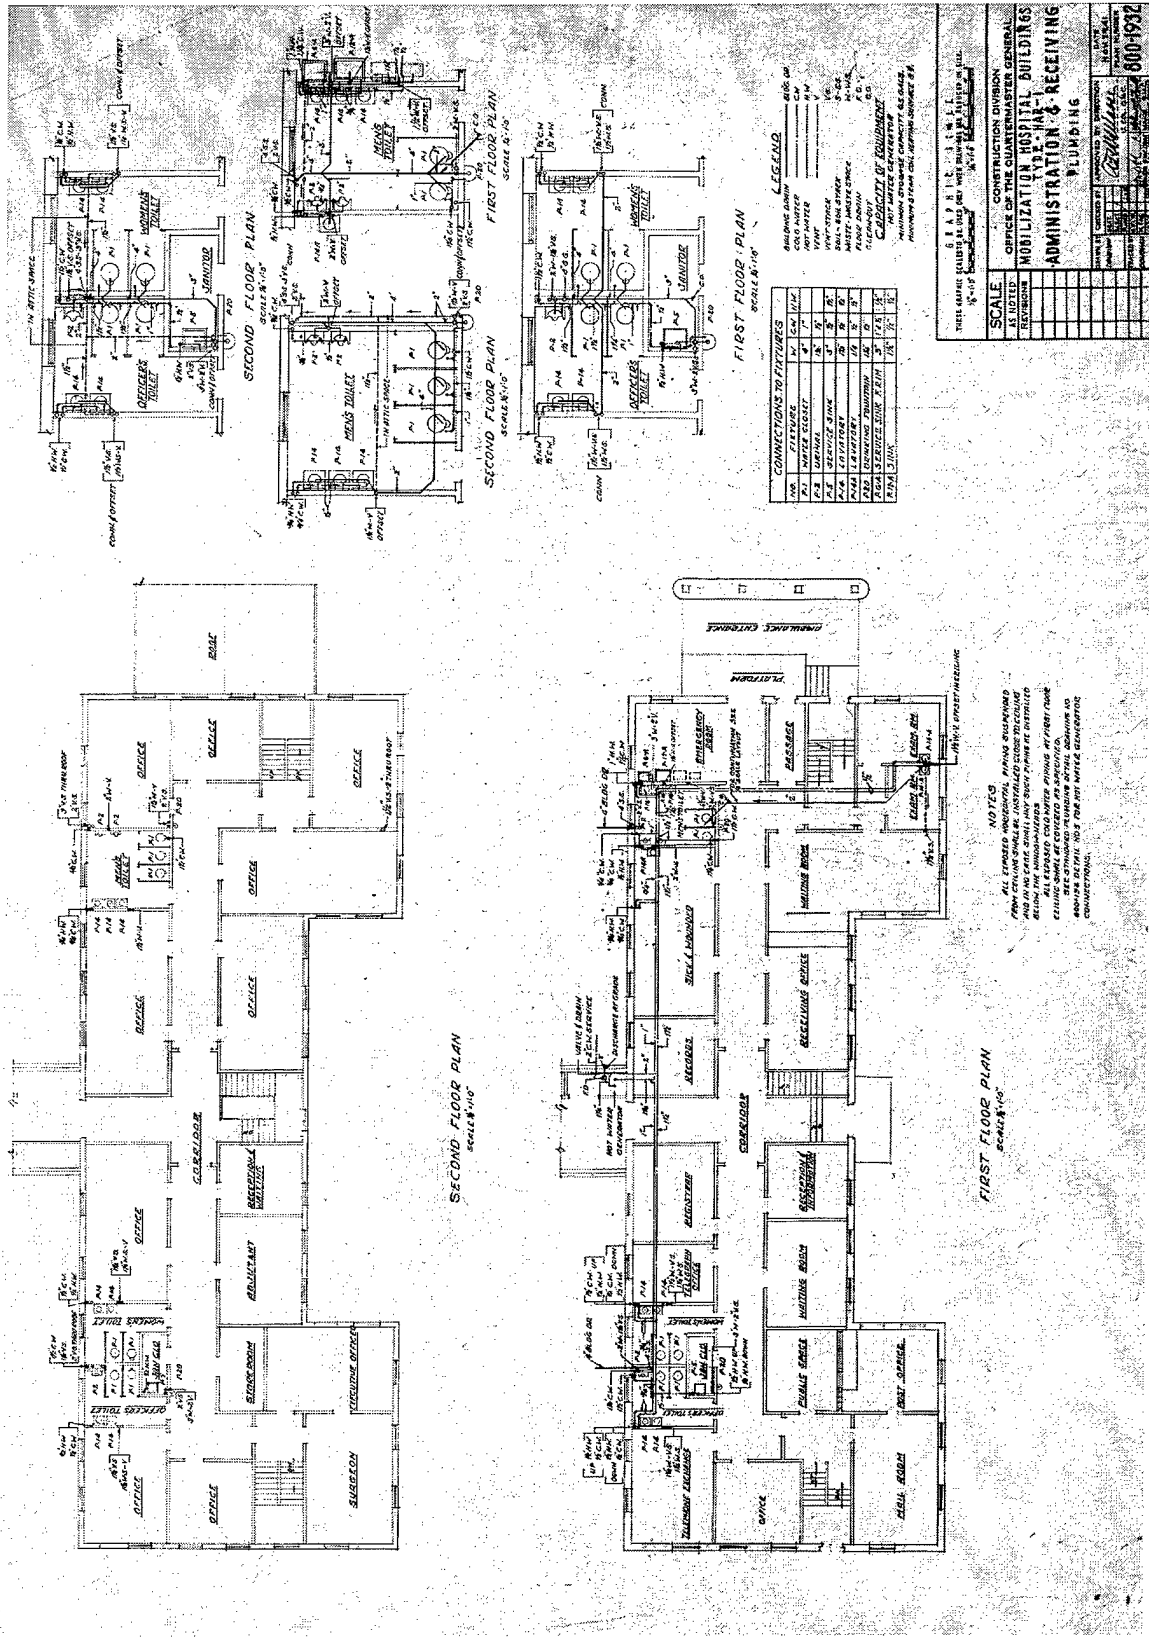
Figure V.22 5EP1778. First- and second-floor plumbing plan for Building S6226, Administration and Receiving, 800 Series, Type HAR-1, Plan 800-1932.

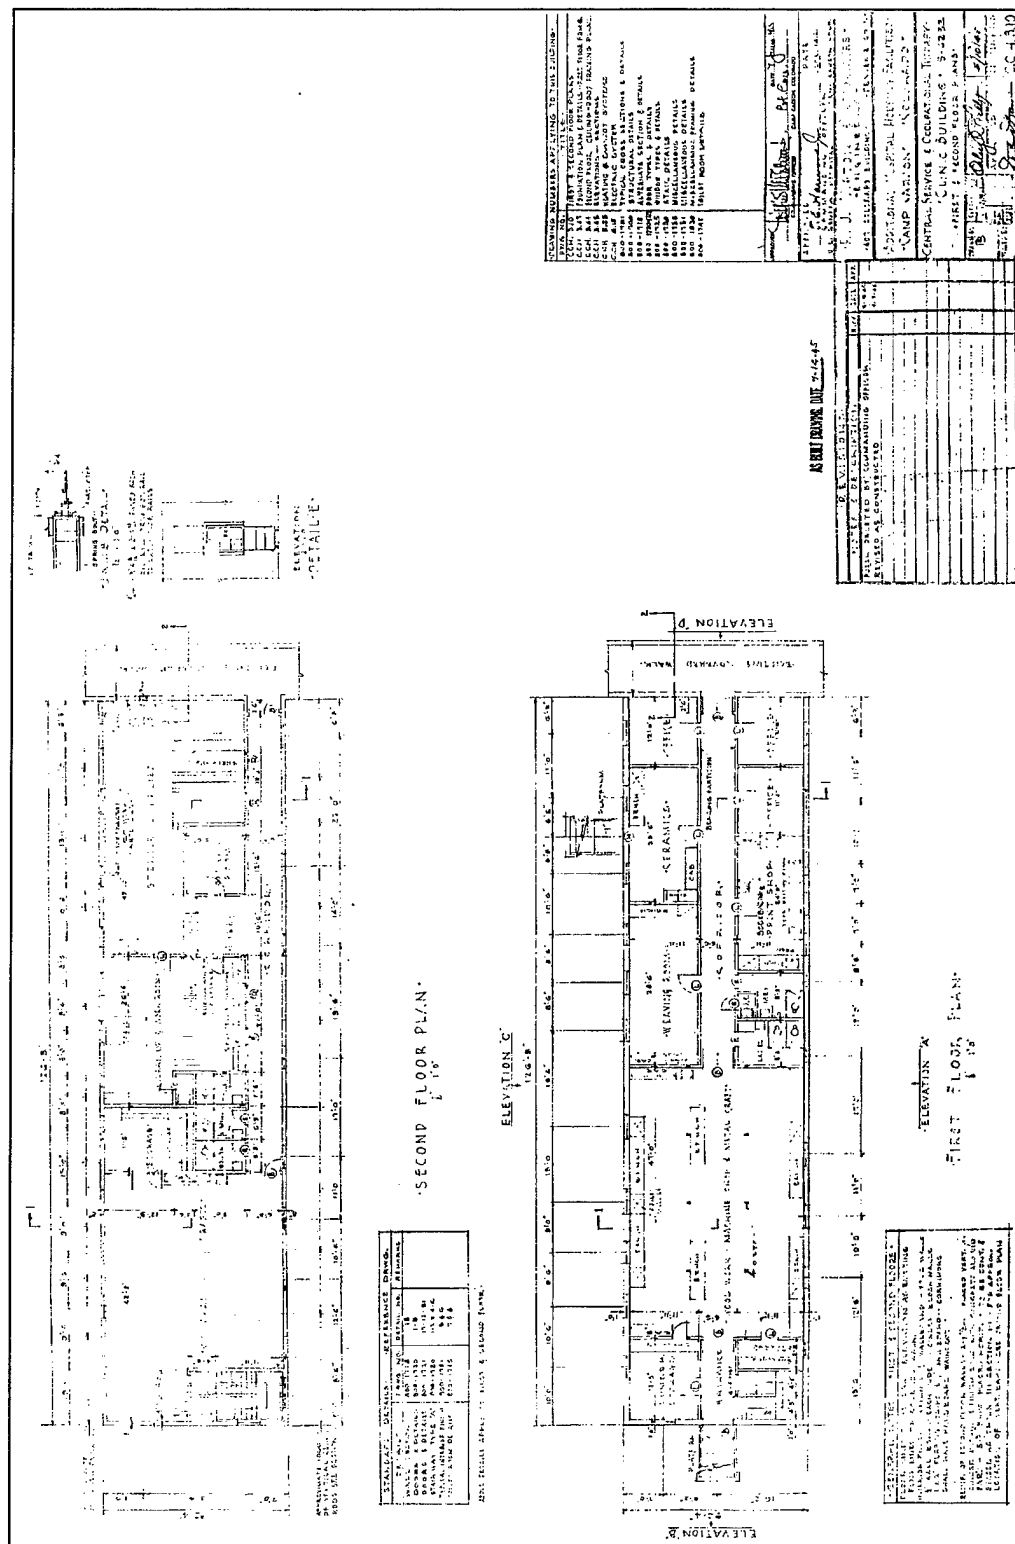
Figure V.31 SEP1778. First- and second-floor plans for Building S6232, Central Service and Occupational Therapy, Clinic Building, CCH Series, Sheet 4.3.10.

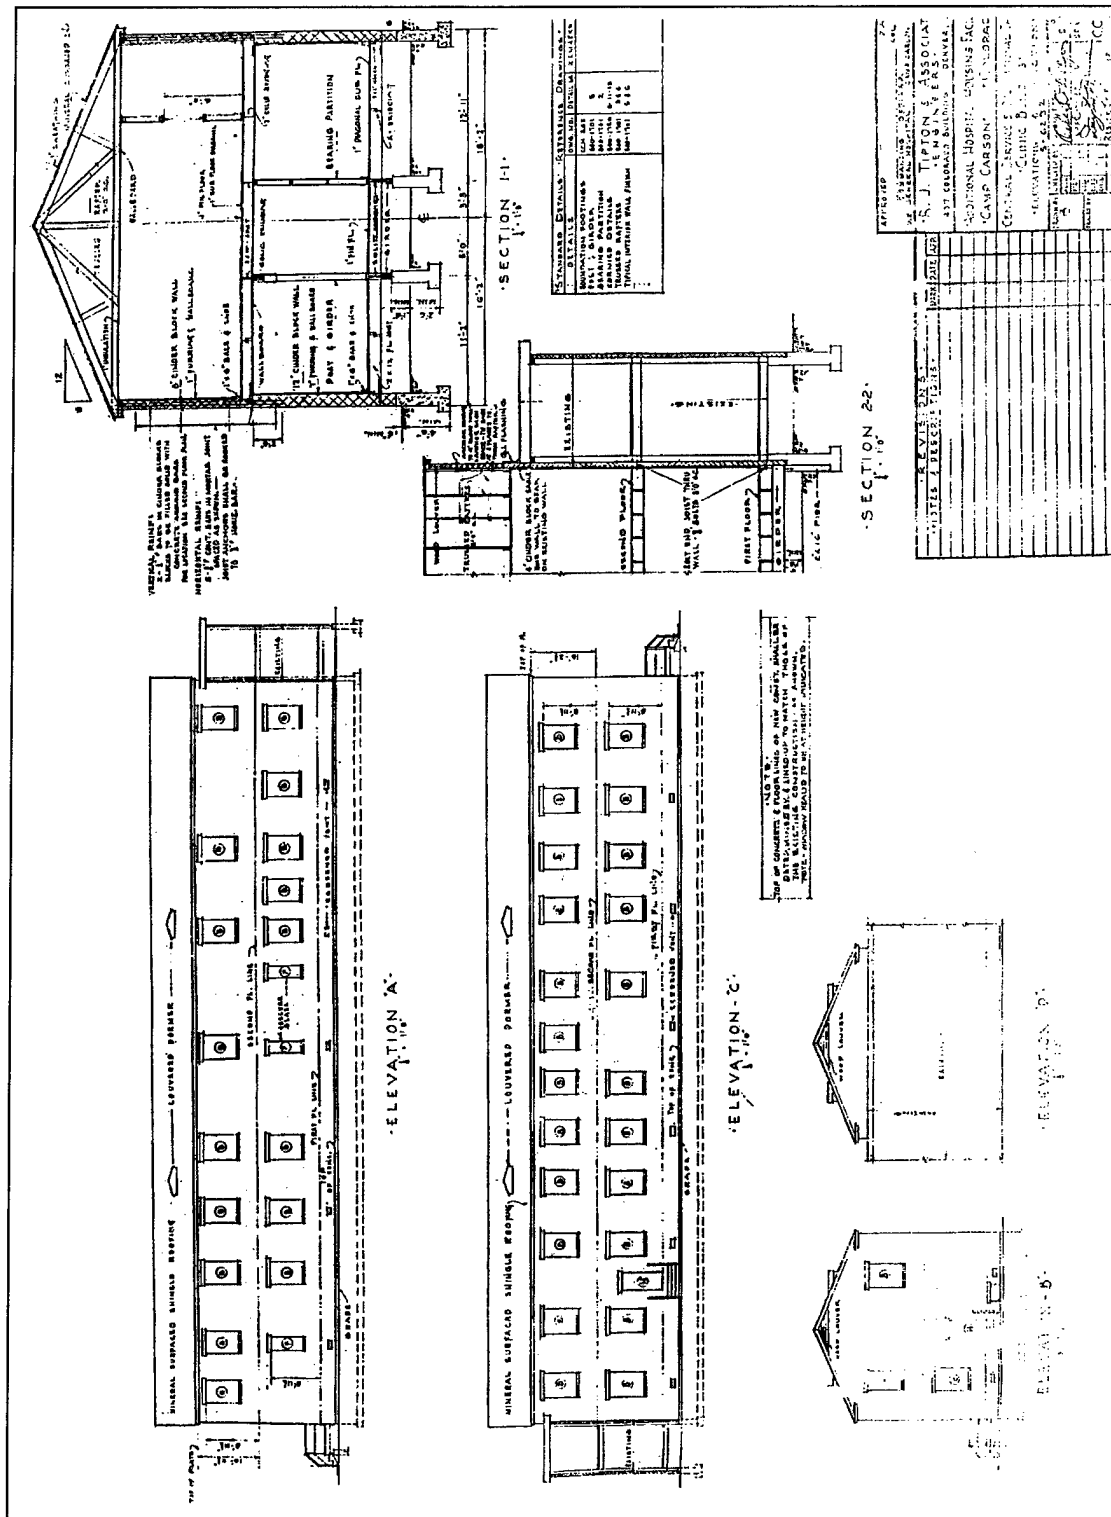
Figure V.32 5EP1778. Elevation and sections for Building S6232, Central Service and Occupational Therapy, Clinic Building, CCH Series, Sheet 3 (illegible).

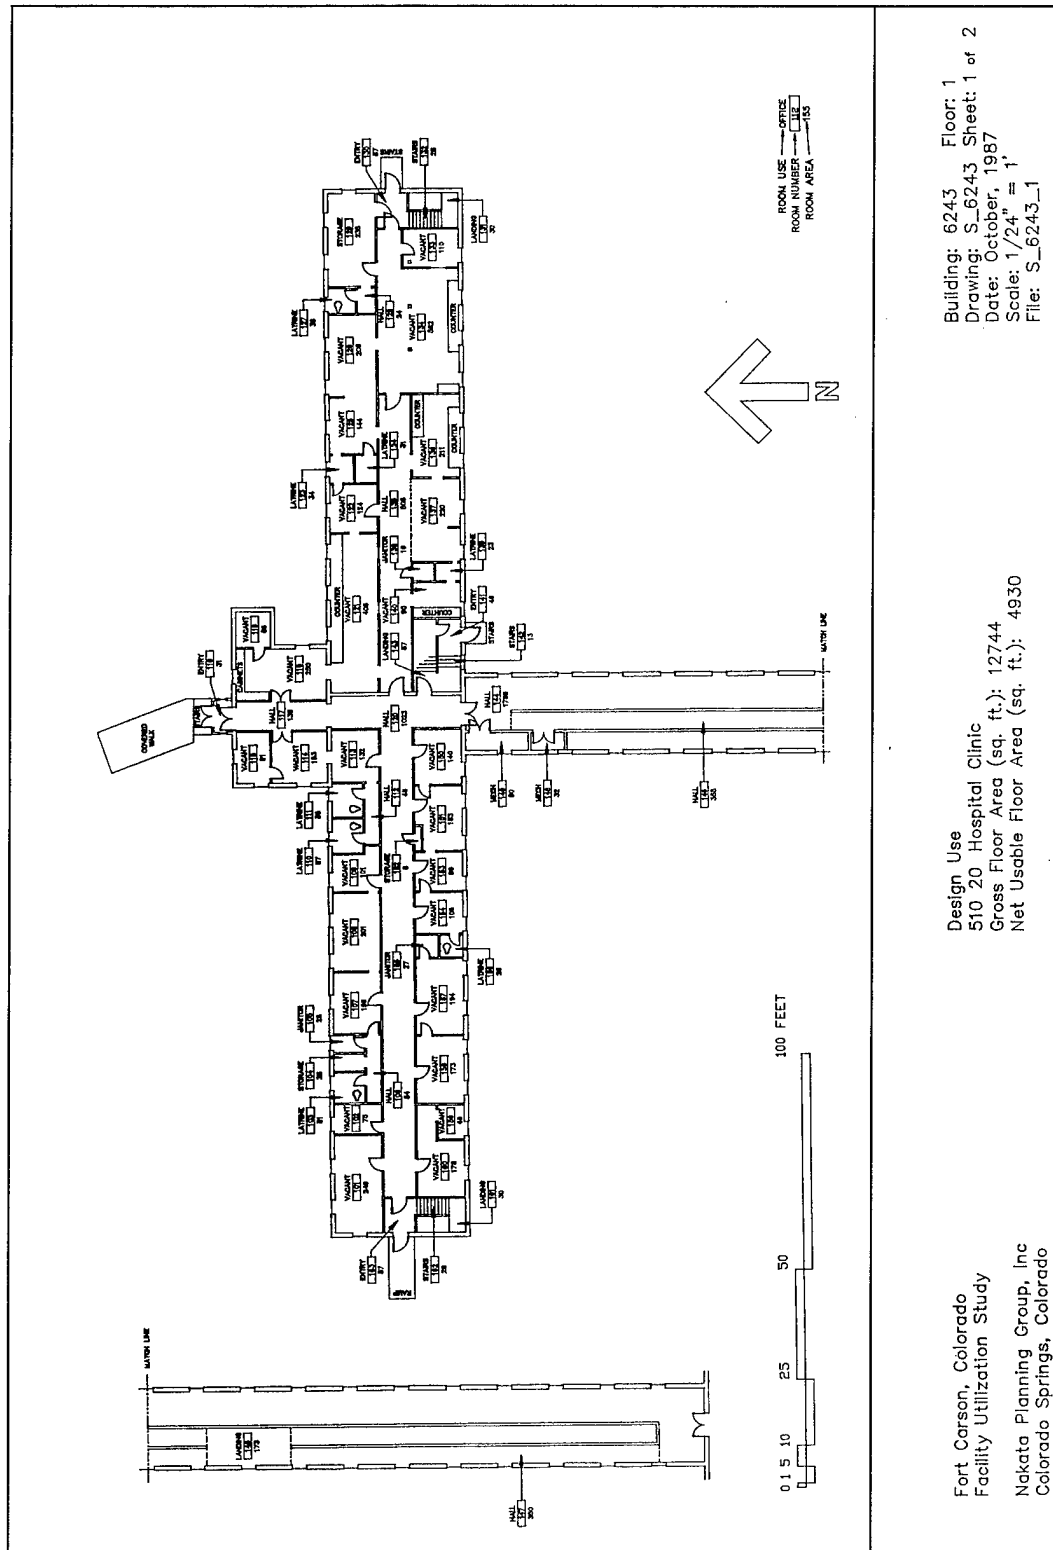
Figure V.36 5EP1778. First-floor plan for Building S6243, Clinic, BUD Series.

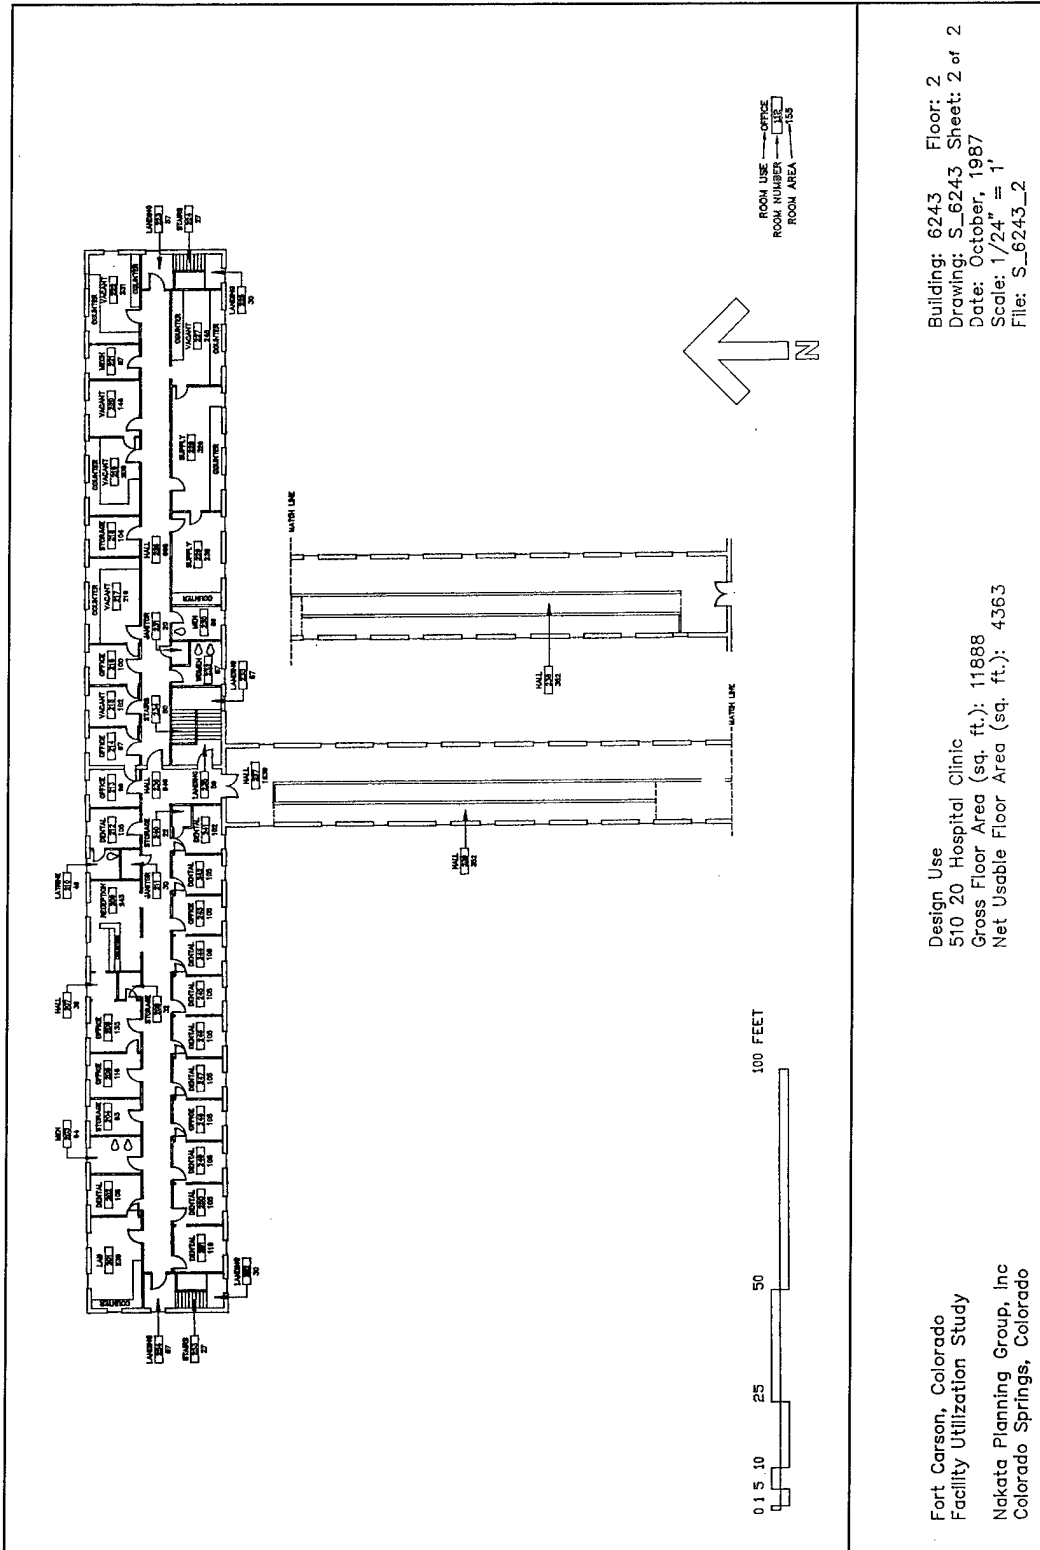
Figure V.37 SEP1778. Second-floor plan for Building S6243, Clinic, BUD Series.

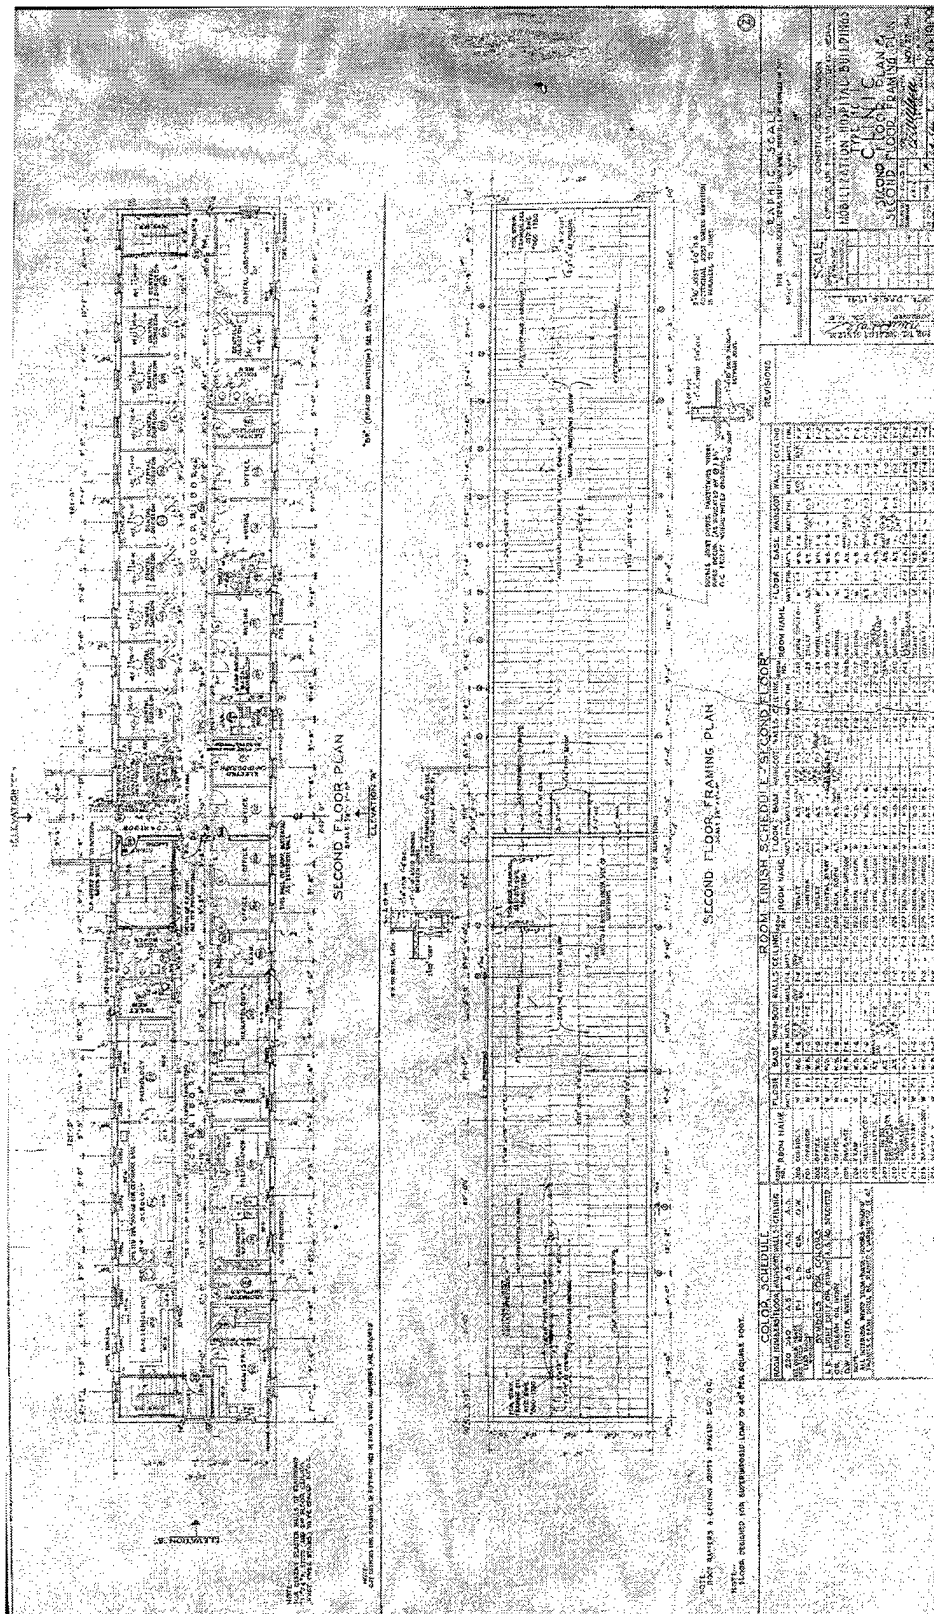
Figure V.39 5EPI778. Second-floor framing plan for Building S6243, Clinic, 800 Series, Type HC-1, Plan 800-1909.

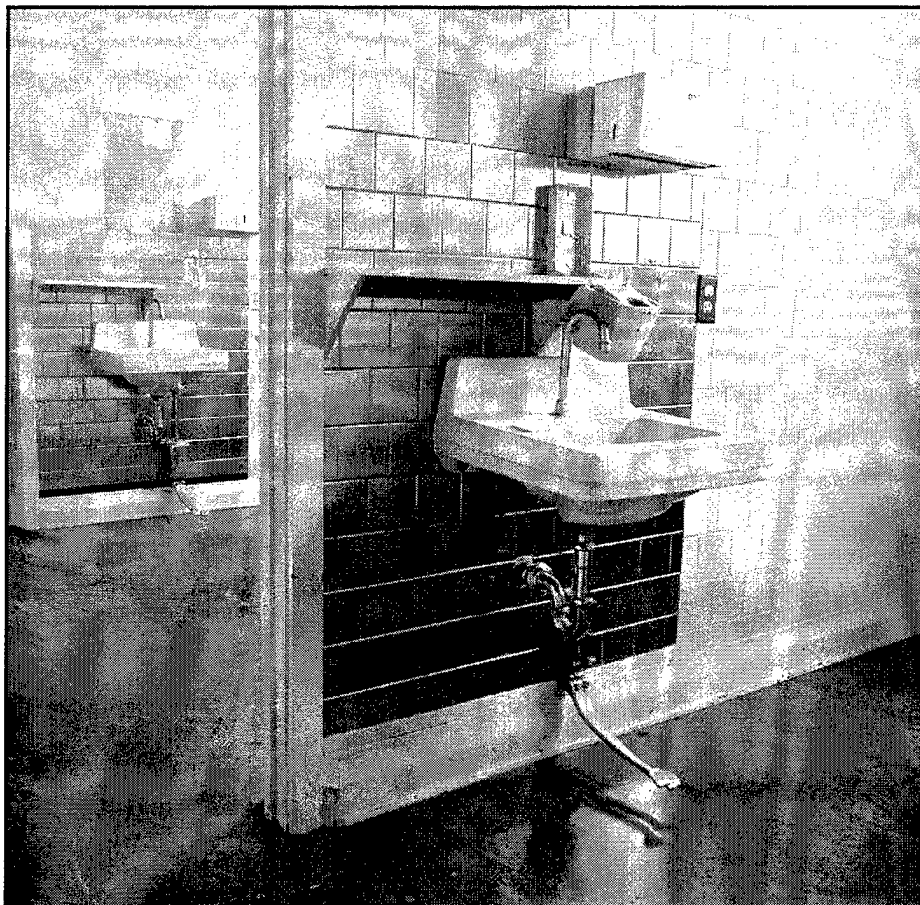
Figure V.46 5EP1778. Building S6243, Clinic, 800 Series, Type HC-1. Interior shot, second floor, of bathroom sinks with pedals. Roll 1E, Exposure 11.

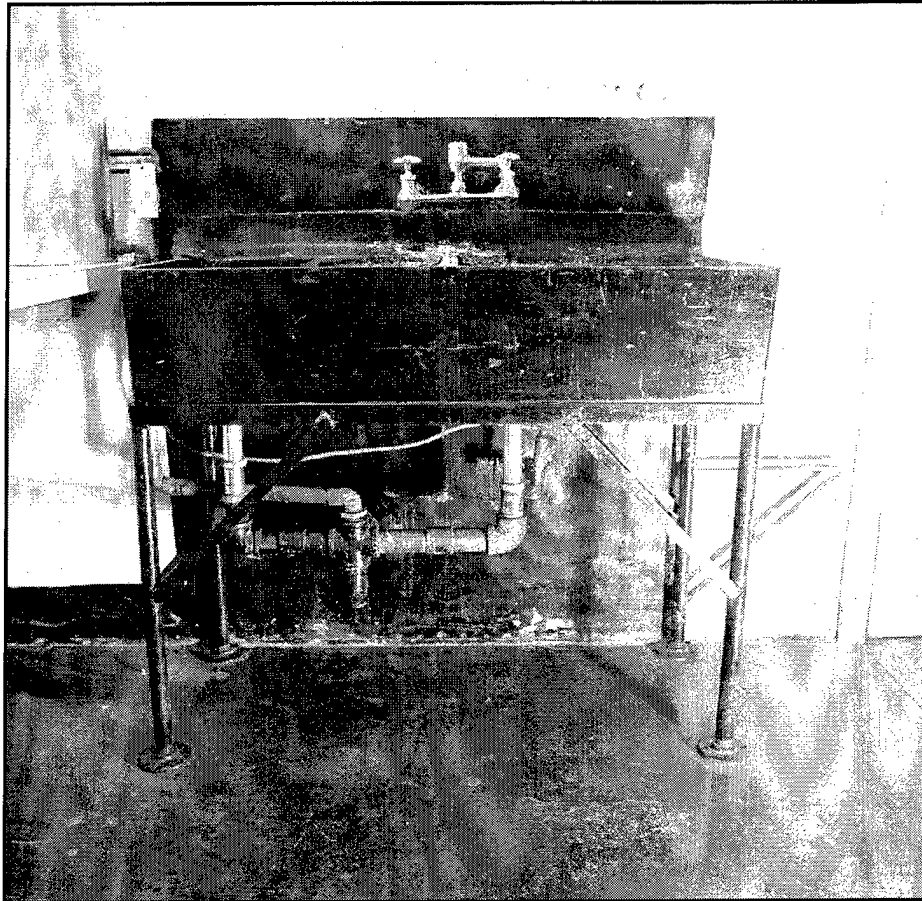
Figure V.47 5EP1778. Building S6243, Clinic, 800 Series, Type HC-1. Interior shot, second floor, of sink in special chemistry room. Roll 1E, Exposure 8.

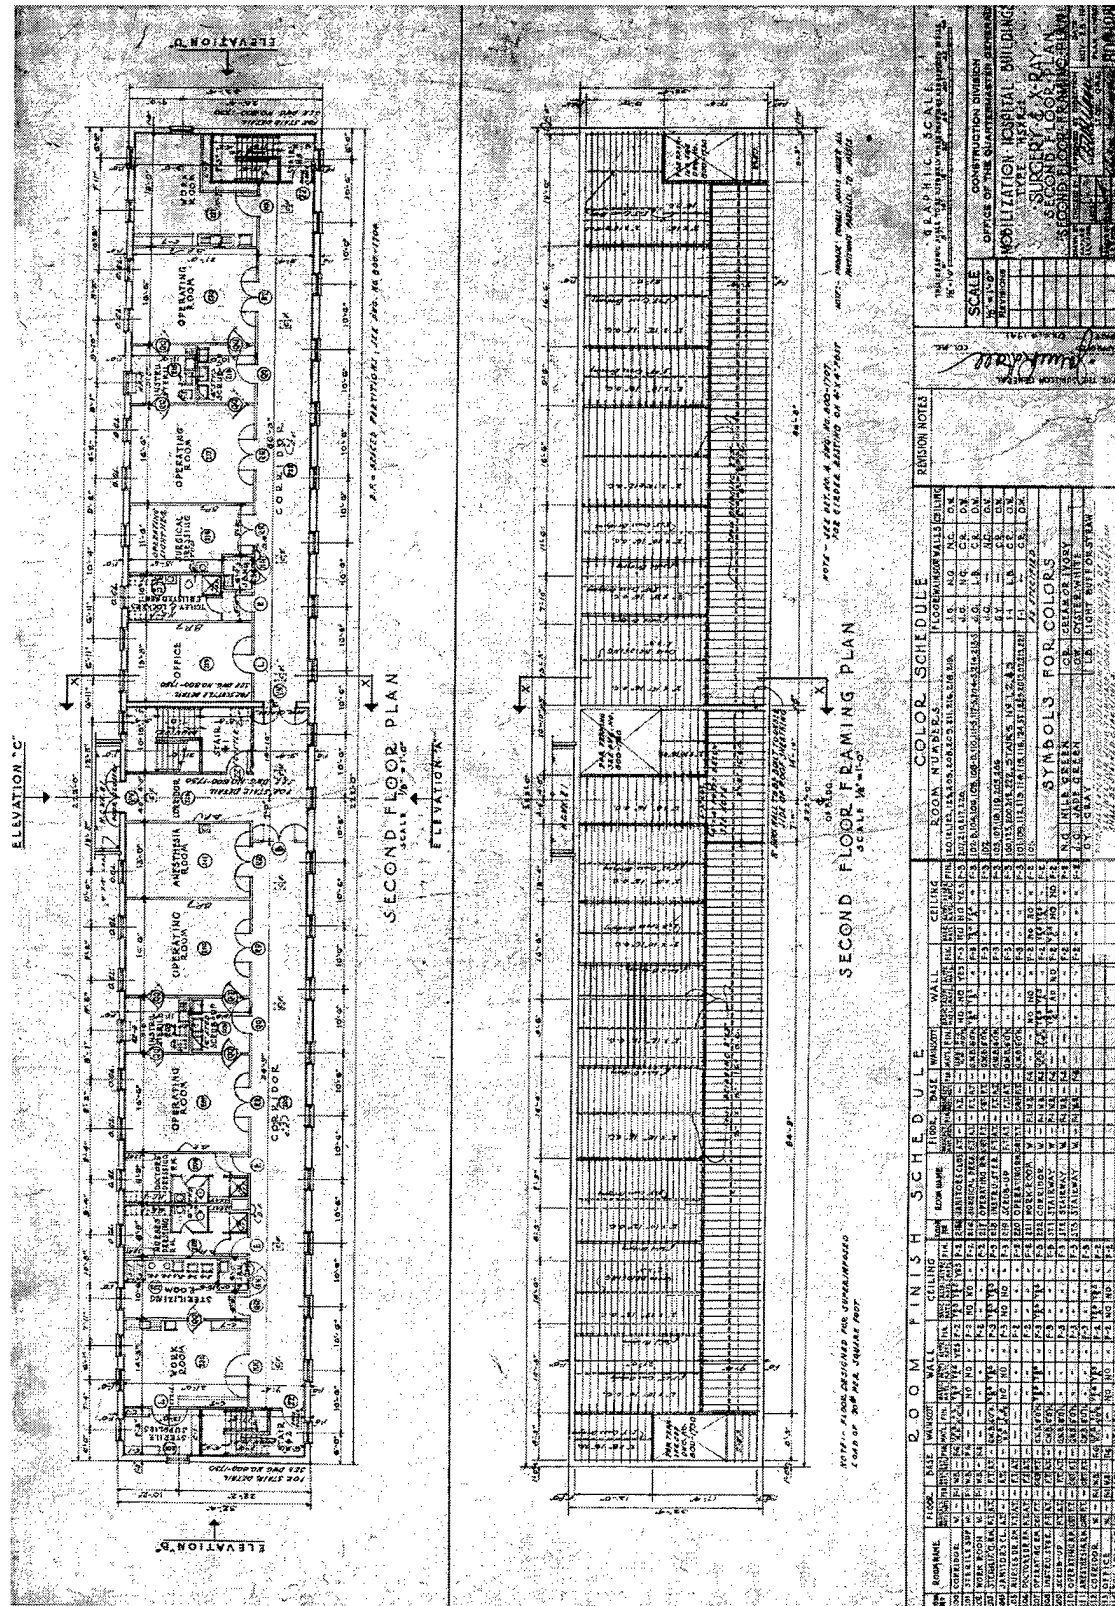
Figure V.55 5EP1778. Second-floor plan for Building S6233, Surgery and X-Ray. 800 Series, Type HSXR-1, Plan 800-1988.

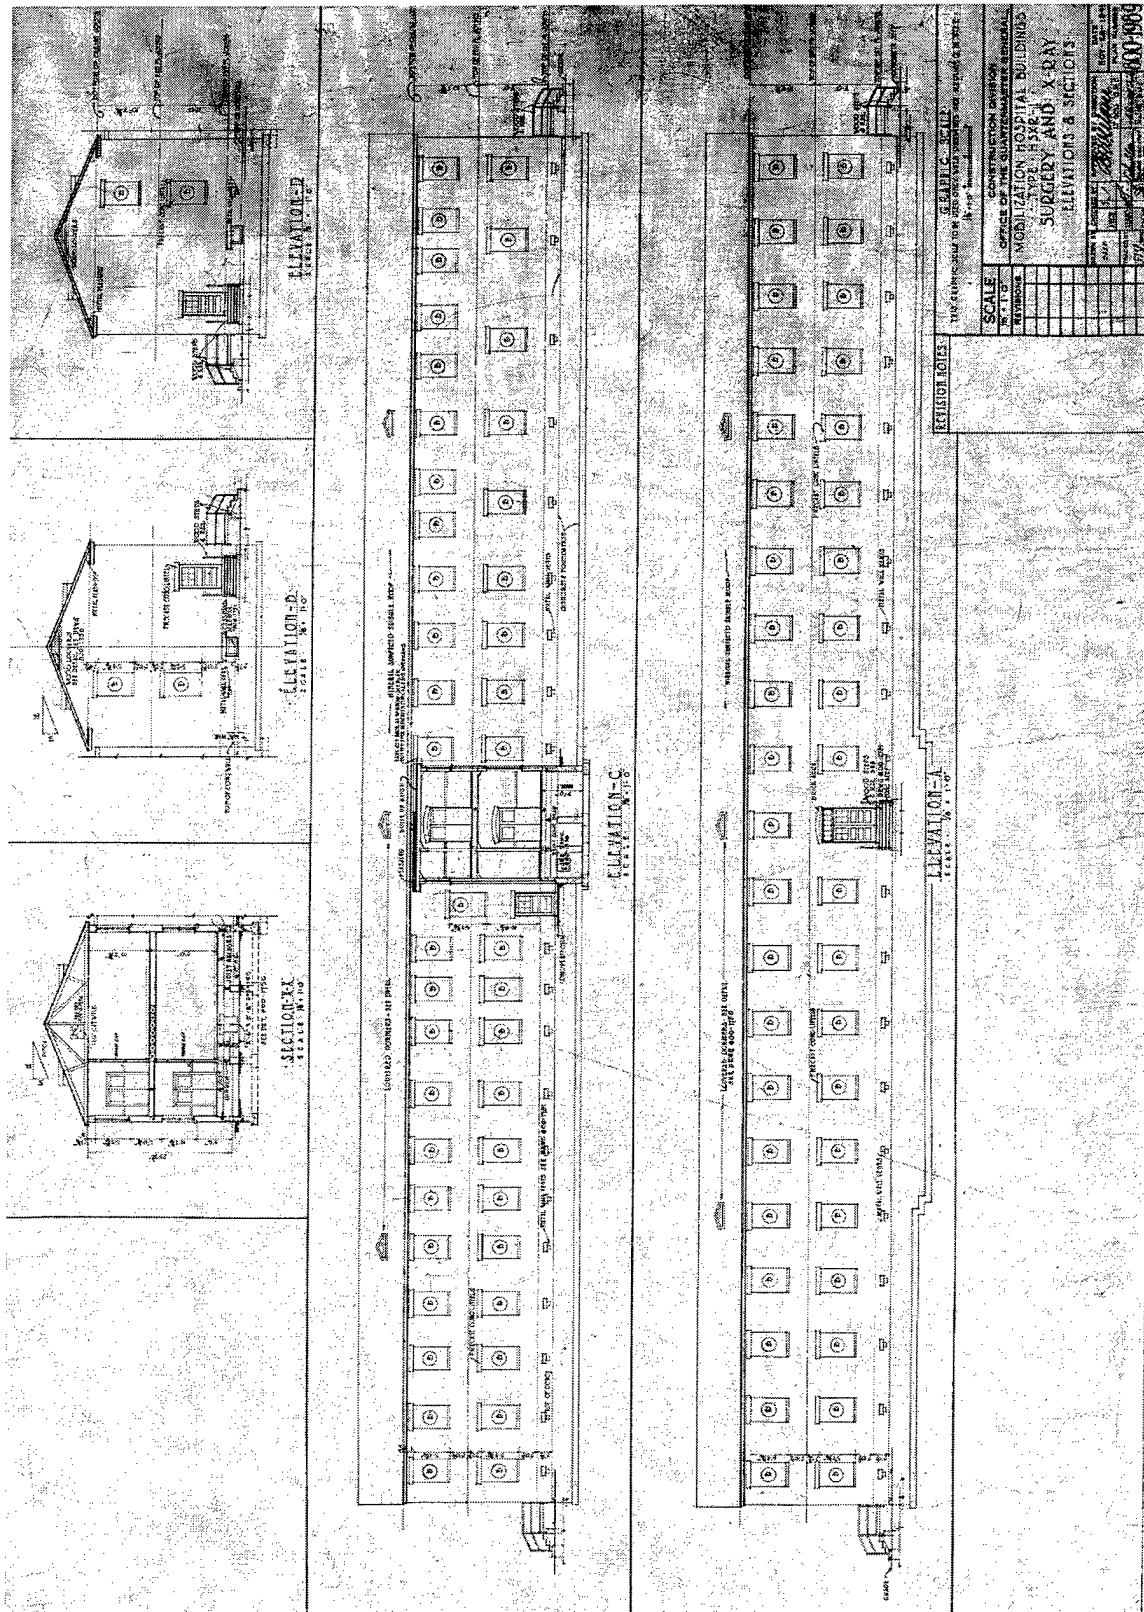
Figure V.56 5EP1778. Elevations and sections for Building S6233, Surgery and X-Ray. 800 Series, Type HSXR-1, Plan 800-1989.

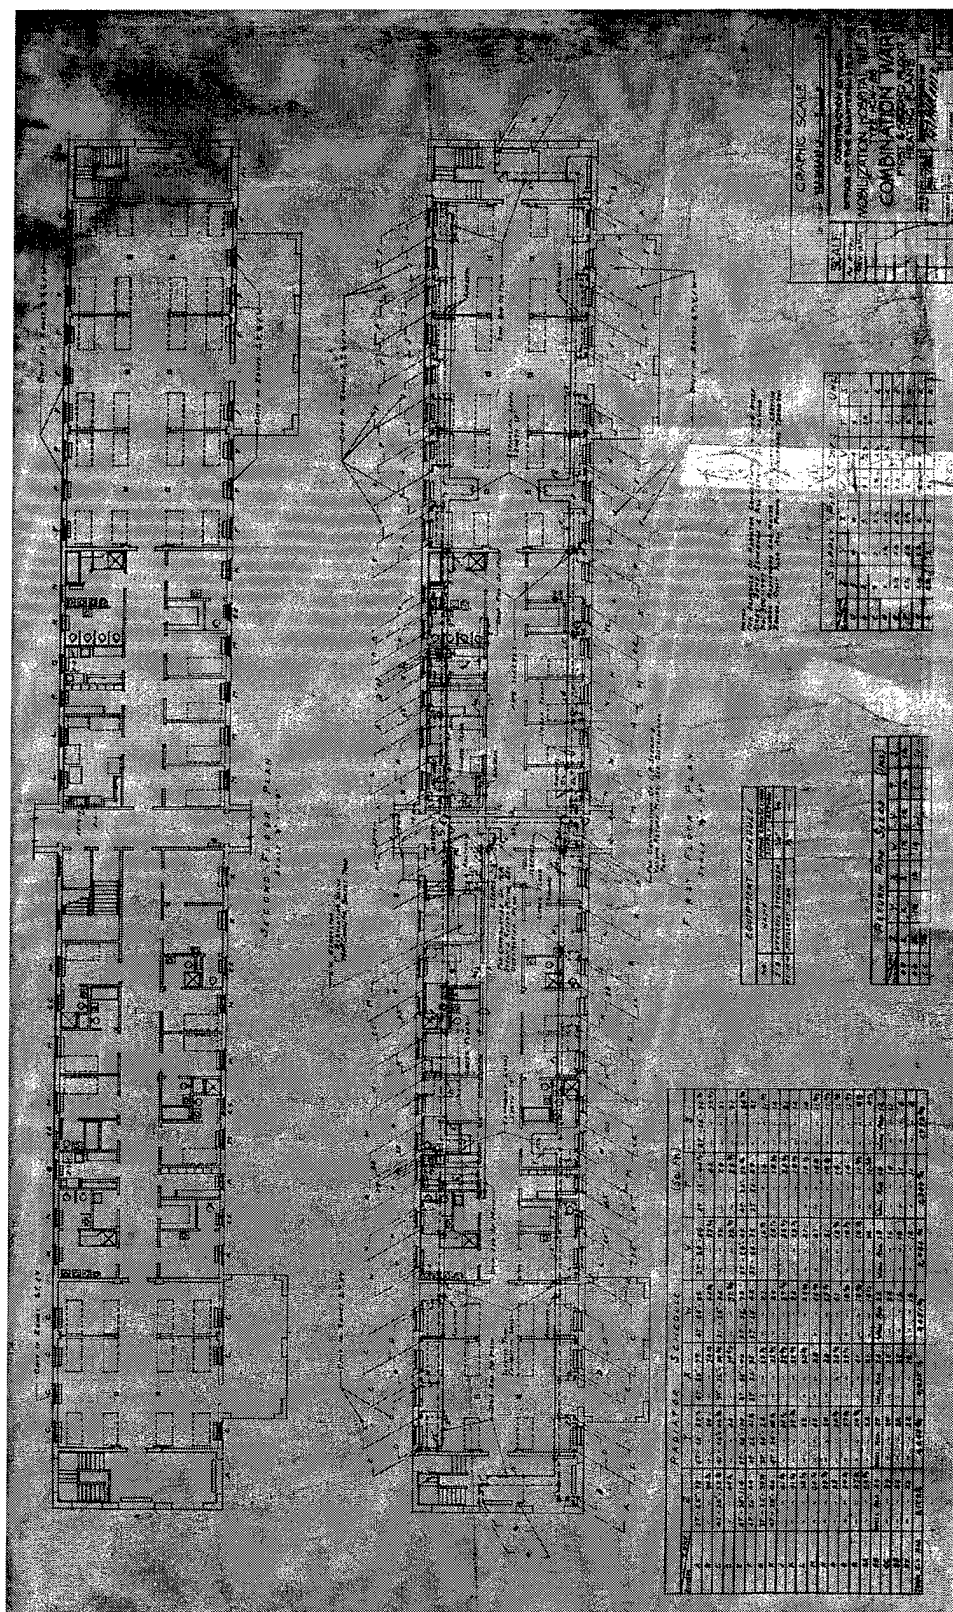
Figure V.62 5EPI778. First- and second-floor heating plans for Building S6230, Combination Ward. 800 Series, Type HCW-88, Plan 800-1946.
